WITNESS GROUP CHAIRMAN'S FACTUAL REPORT
Attachment C: Summaries of Other Information Interviews
(46 pages)

**SUMMARY OF THEORY INTERVIEW
CONCERNING THE I-35W BRIDGE COLLAPSE**

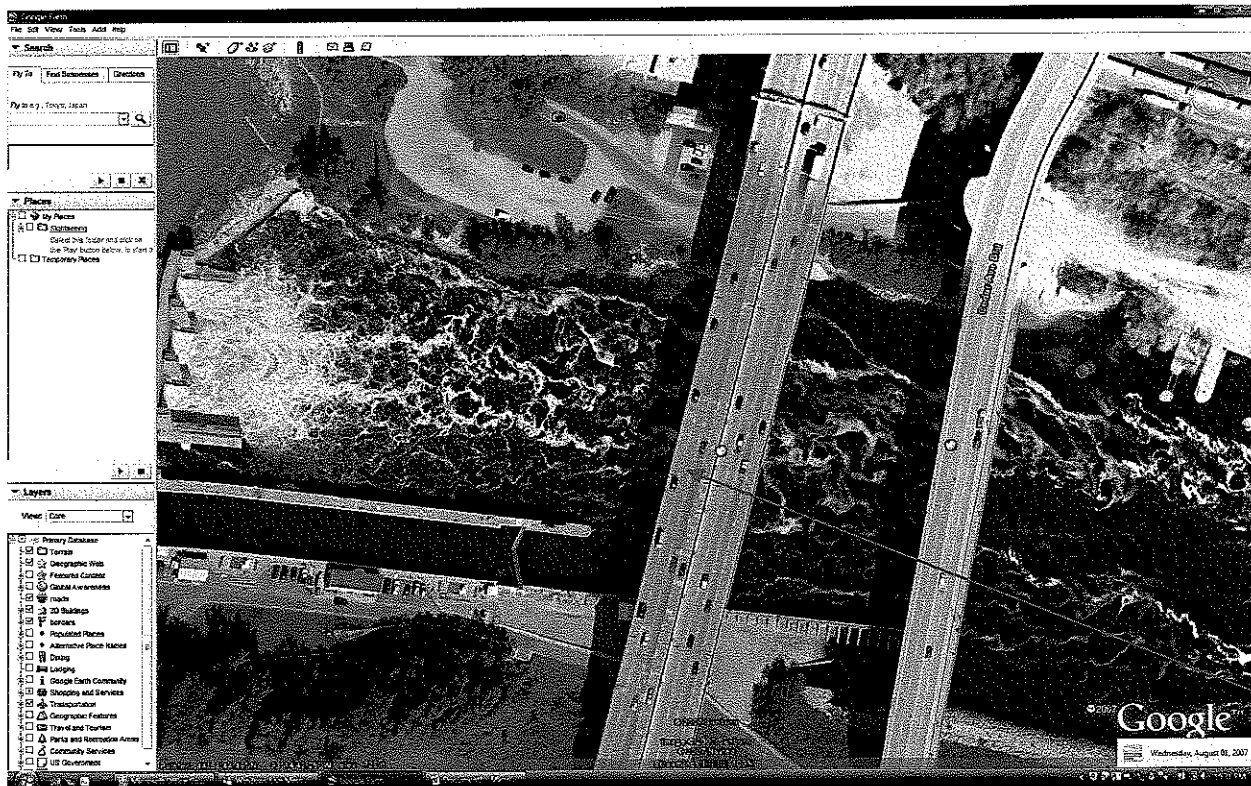
Image 1 I-35W Mississippi River Crossing (SB Leg)

- Traffic was moving at approximately 10 – 20 mph
- At the location indicated on Image 1, traffic was at a complete stop, and I began to experience a noticeable circular motion/oscillation on the front end of my pick-up that was horizontal and counter-clockwise in nature. This struck me as odd, as I have travelled this very route over this very bridge for 20 years to and from work in SE MPLS, and in all types of traffic conditions (including stopped traffic), and I have never felt such an uncomfortable sensation as this. In fact I distinctly recall two thoughts I had at this moment:

Approximate location during SB travel – Experienced a noticeable sway that was horizontal and counter-clockwise in motion.

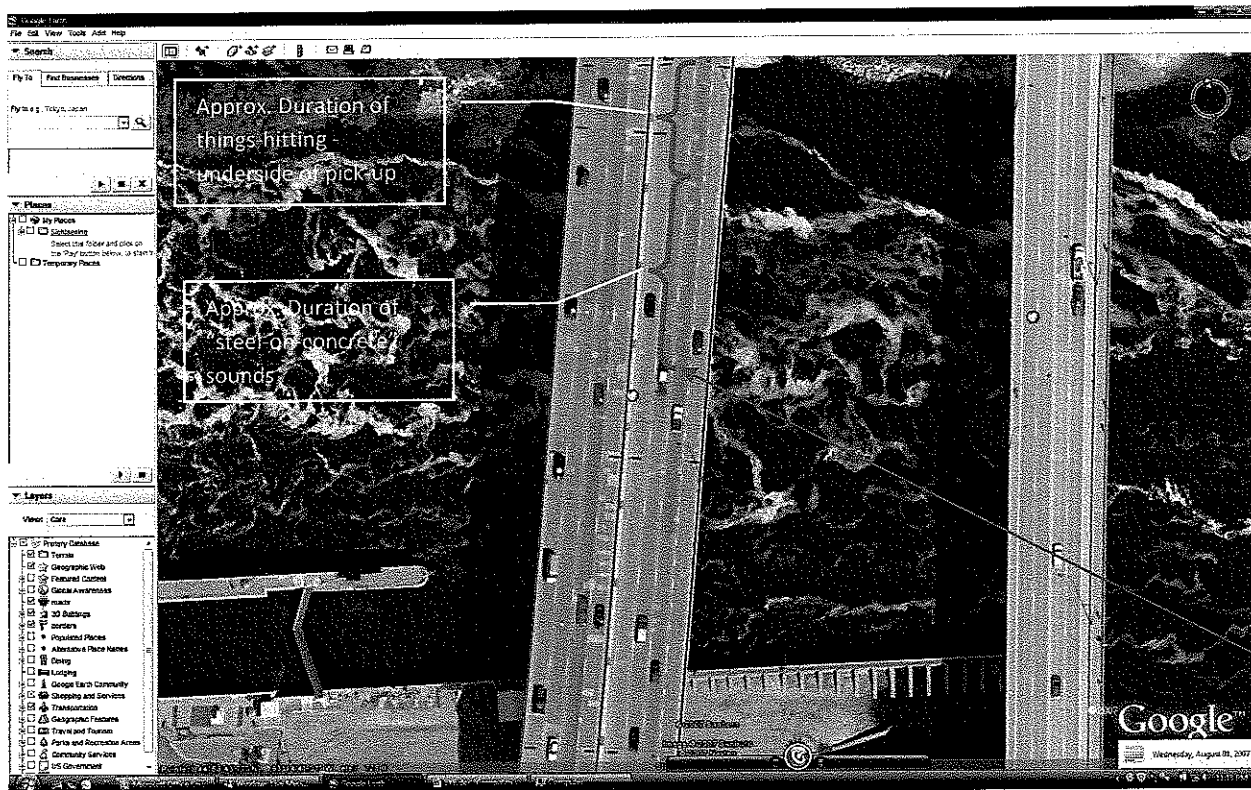
Image 2 I35W Mississippi River Crossing (NB Leg)

- And there were no workers to my left that I could see to drop anything
 - There were 3 distinct instances of this sound, (and a questionable 4th) over a duration of approximately 3 – 5 seconds.

- Which followed immediately by the sound like my wheels were flinging large-size rocks into the underside of the pick-up, predominantly in the area of the cab...one of which I felt hit beneath the floor-board of my right foot.

Approximate location during NB travel – heard very sharp, loud panging noises, and then noticed items like stones hitting the undercarriage of the truck. My windows were open.
